Manhole Inspection Summary

Manhole # S41C2_007MH

Location Address: **800 Jack St.**

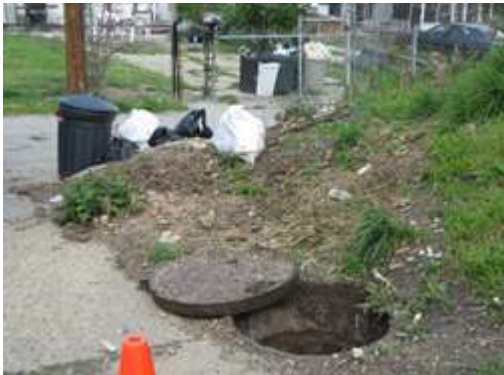
Location View

800 Jack St.

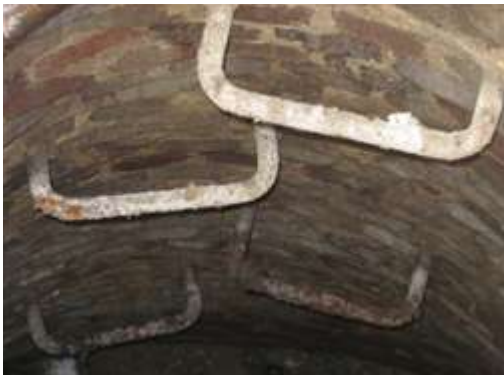
Steps Count: **4** Missing: **0** ☒ **Corroded**

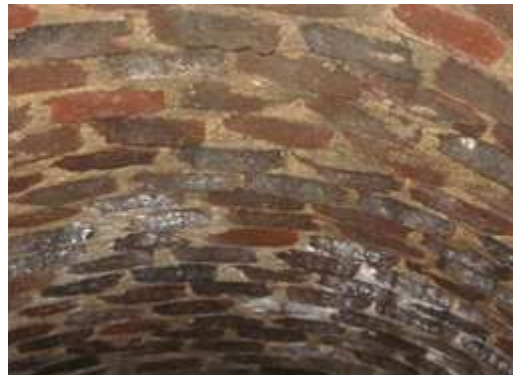
Defect 2

Condition: ☐ Sound ☒ **Cracked** ☐ Root Intrusion ☒ **Loose Brick** ☐ Deteriorated

Infiltration: ☐ None ☒ **Joint** ☒ **Cracks** ☐ Mortar ☐ Roots ☐ Wall

Infiltration

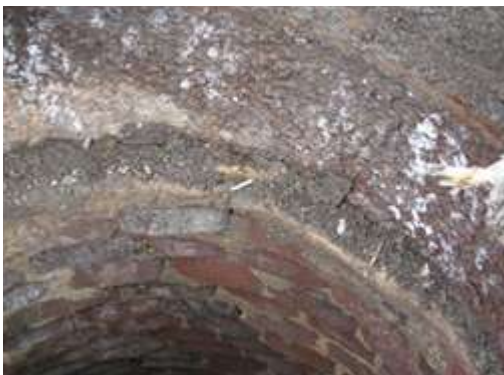
Defect 1

Frame Offset: **2.5** (in.) Condition: ☒ Sound ☐ Cracked ☐ Leaks

Frame-Chimney Offset

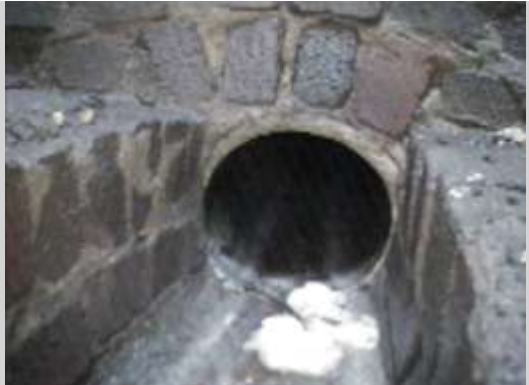
12 O'Clock Outflow

8 in. Circular Gravity Sewer
Pipe Out @ 12 O'Clock

Pipe Height: **8.4** (in.) Rod and Bar (Angled)
Pipe Material: **Clay** ☐ Pipe Lined
Invert Depth: **8.82** (ft.) Flow Characteristics: **Fast**
Deposits: ☐ None ☐ Mud ☒ **Sludge** ☐ **Debris** ☐ Grease
Silt Depth: **1** (in.) Deposits Extent: **Light**
Infiltration: **None** Pipe Seal Cond: **Sound**

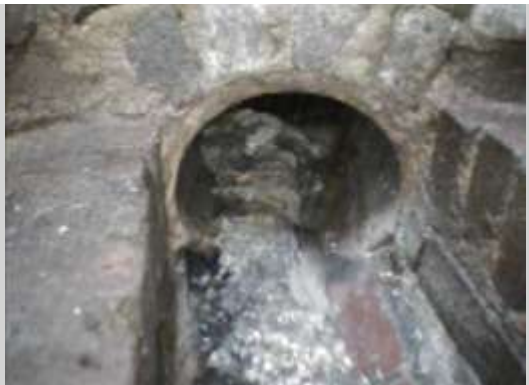
6 O'Clock Inflow

8 in. Circular Gravity Sewer
Pipe In @ 6 O'Clock

Pipe Height: **8.4** (in.) Rod and Bar (Angled)
Pipe Material: **Clay** ☐ Pipe Lined
Invert Depth: **8.40** (ft.) Flow Characteristics: **Fast**
Deposits: ☐ None ☐ Mud ☒ **Sludge** ☒ **Debris** ☐ Grease
Silt Depth: **2** (in.) Deposits Extent: **Light**
Infiltration: **None** Pipe Seal Cond: **Sound**
